Merion Friends Meeting House: Documentation & Site Analysis

David Mark Facenda
University of Pennsylvania

MERION FRIENDS MEETING HOUSE: DOCUMENTATION & SITE ANALYSIS

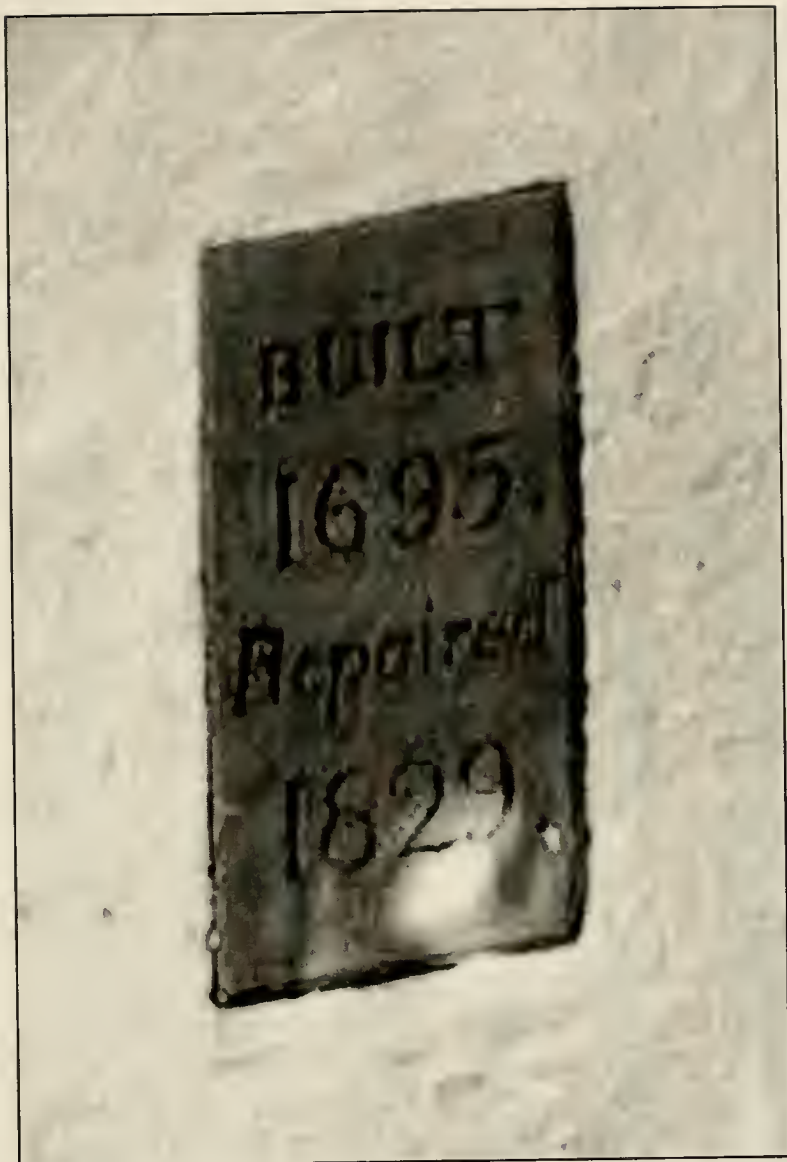
The date stone located over the attic window in the northwest gable wall is among the most controversial pieces of evidence used to date the building (Figure 14). The inscription in the stone reads: "Built 1695, Repaired 1829." This simple plaque has perpetuated and reinforced the notion that the meetinghouse was built in 1695, but many believe it to be misleading. It was likely placed there in 1829, following the separation between the Hicksites and the Orthodox Friends, when the title to the meetinghouse was relinquished to the Hicksite faction. Although the minutes for the period of separation are missing, material evidence indicates that the most substantial alterations to the original building were made in 1829 when the building was "Repaired." For some historians, the most regrettable alteration during this period was the application of the exterior stucco. Reflecting the fashions of the period, the

Figure 14:
Date stone, northwest gable wall.
Photograph by author, 2001.

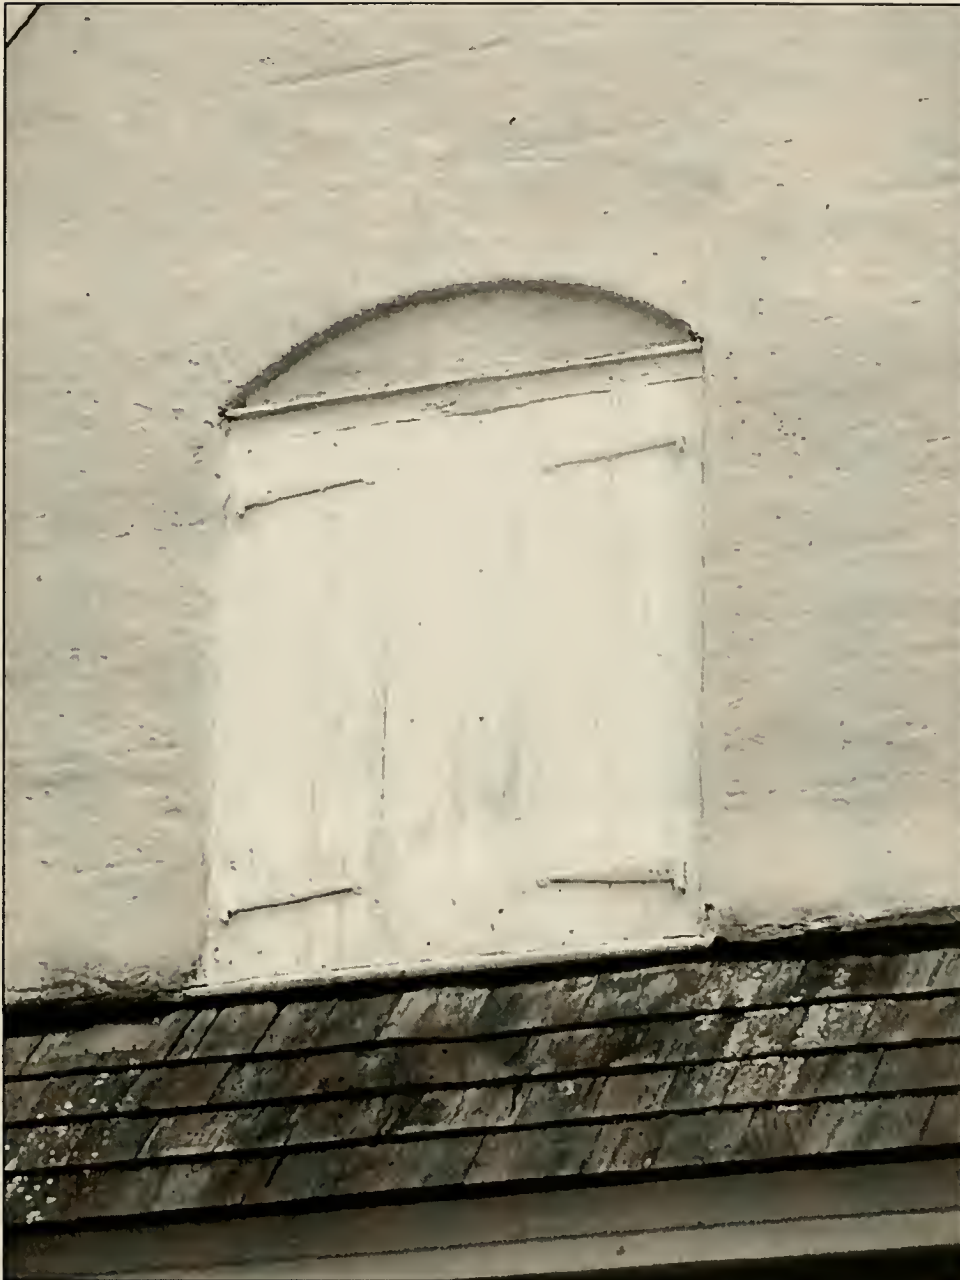
block, but the incised detail has worn away and is no longer obvious. The scored lines that simulate mortar joints can still be seen on some portions of the exterior walls and are evident in historical photographs (Figure 15).

Figure 15:
Attic window, east exterior elevation.
Exterior stucco has been scored to resemble ashlar stone blocks. The shutters conceal one of the two surviving casement window frames. Photograph by author, 2001.

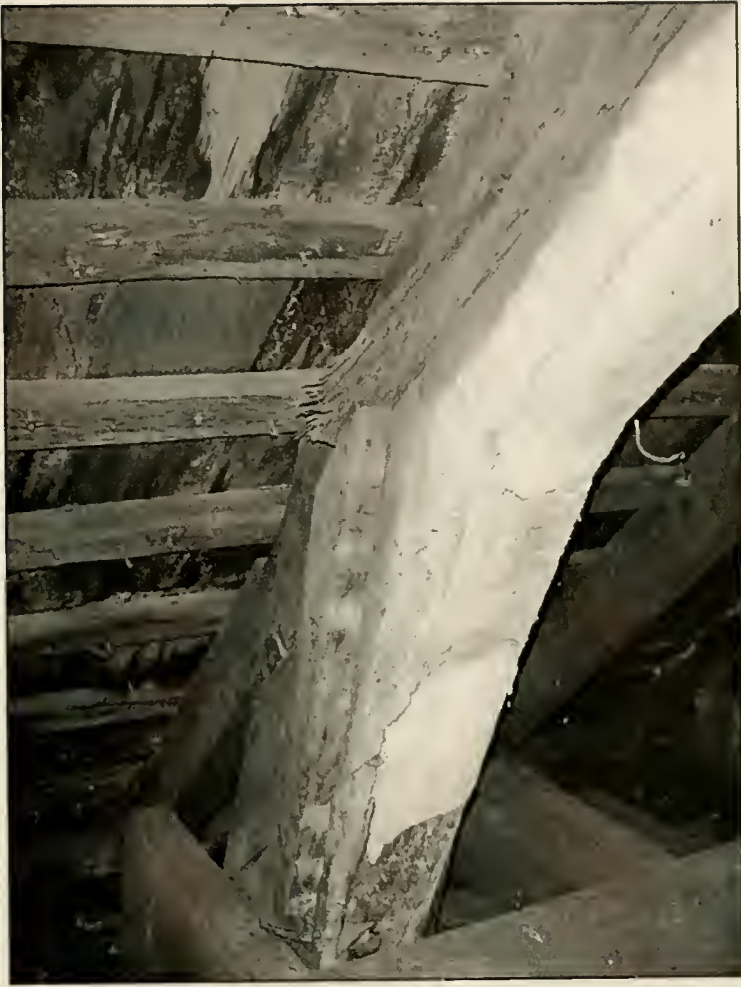
Figure 26:
Base of "cruck" principal rafter in present attic space over north section. Remnants of plaster indicate that the ceiling was once open to the rafters.
Photograph by author, 2002.

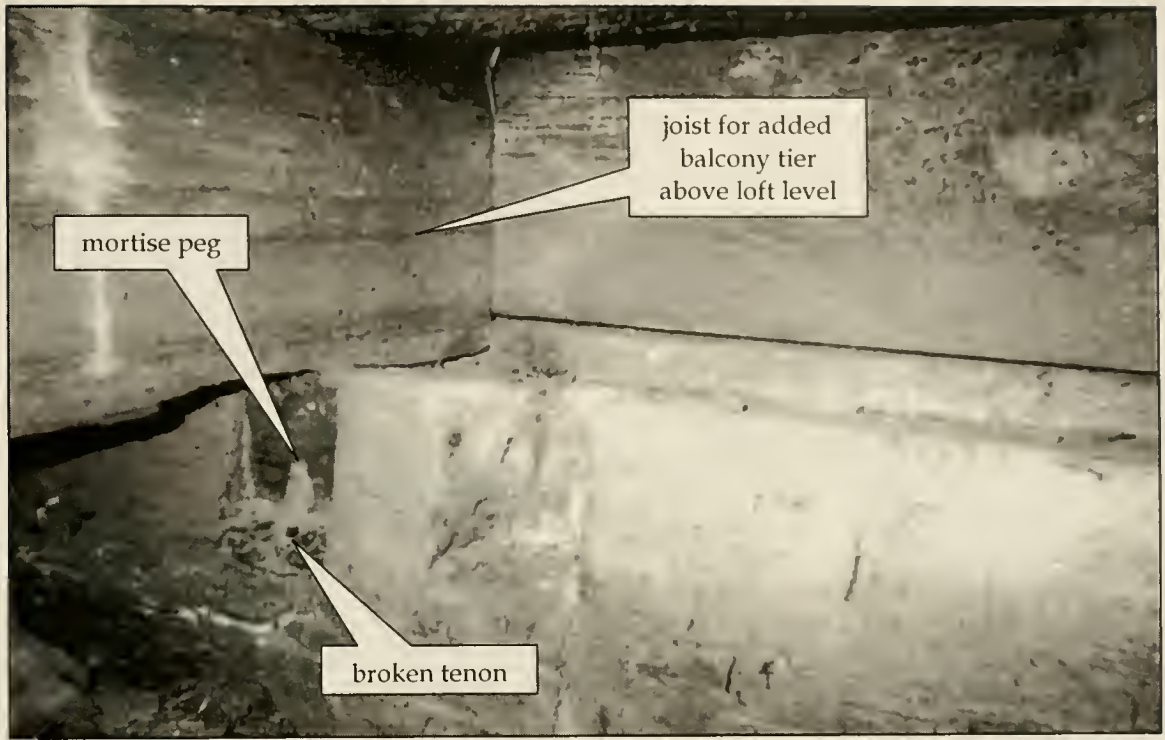
Figure 39:
Vacant mortise pocket with broken tenon
and peg in recycled balcony beam.
Photograph by author, 2002.

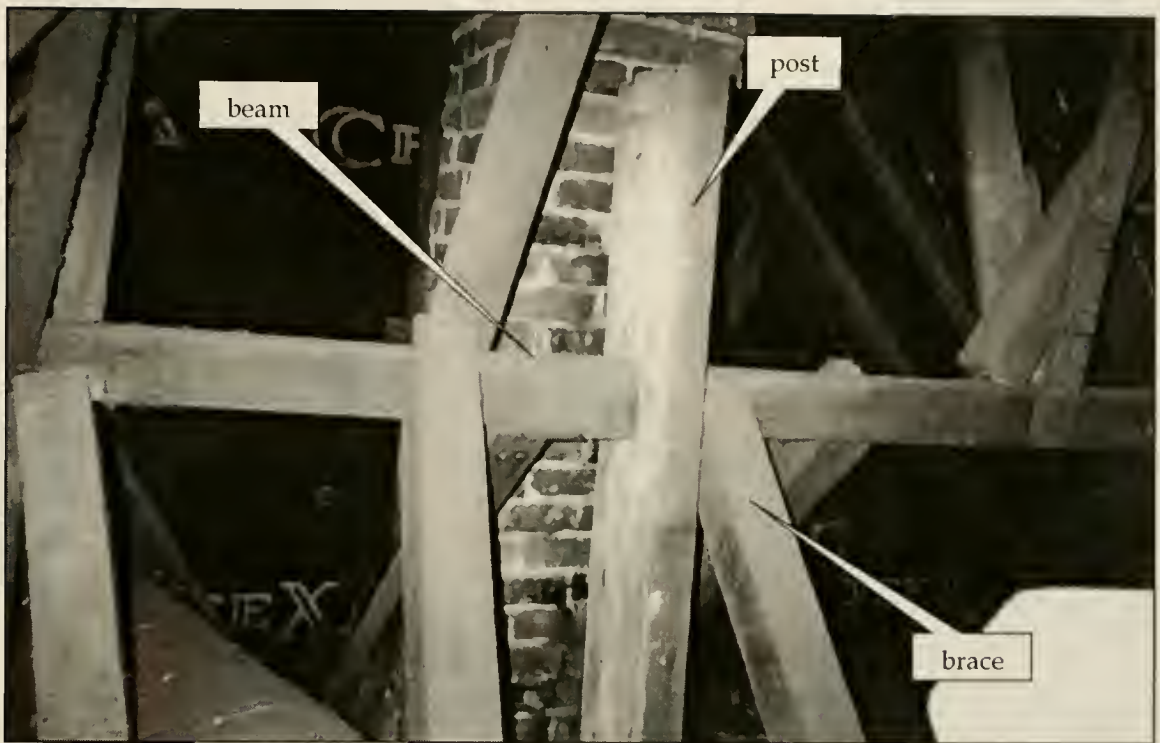
The lumber used for the jerry-rigging shows marks of pit-sawing and appears to be recycled from original roof framing members. Several of the joists that run among the collar beams of the principal rafter assemblies over the loft are missing. The third, fourth, and fifth joists, counting from the west, that extended between the south gable wall and the first assembly have been sawed off near the wall plane (Figure 52). The south ends of the joists are still visible in their masonry pockets. The reason for their removal is unclear. The sixth joist, counting from the west, which spanned between the first and second assemblies over the south section, has also been removed. The diagonal braces of the jerry-rigged support frame were built from lumber of similar dimensions as these collar joists. It is possible that these four joists were removed and re-used in the jerry-rigged support frame when the chimney was built circa 1829.

Figure 46:
Detail of rigged A-frame roof support and central chimney installed circa 1829. The beam and braces appear to be pit-sawn members recycled from the original roof structure.
Photograph by author, 2002.

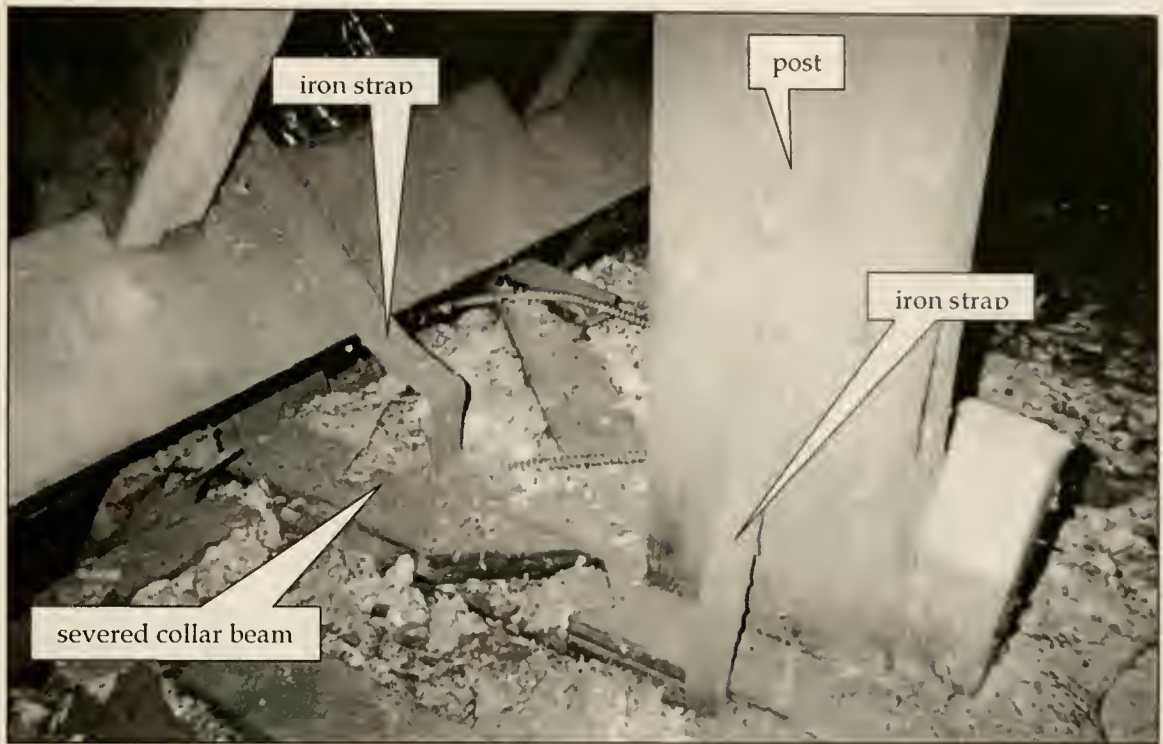
Figure 47:
Detail of rigged A-frame roof support
installed circa 1829.
Photograph by author, 2002.

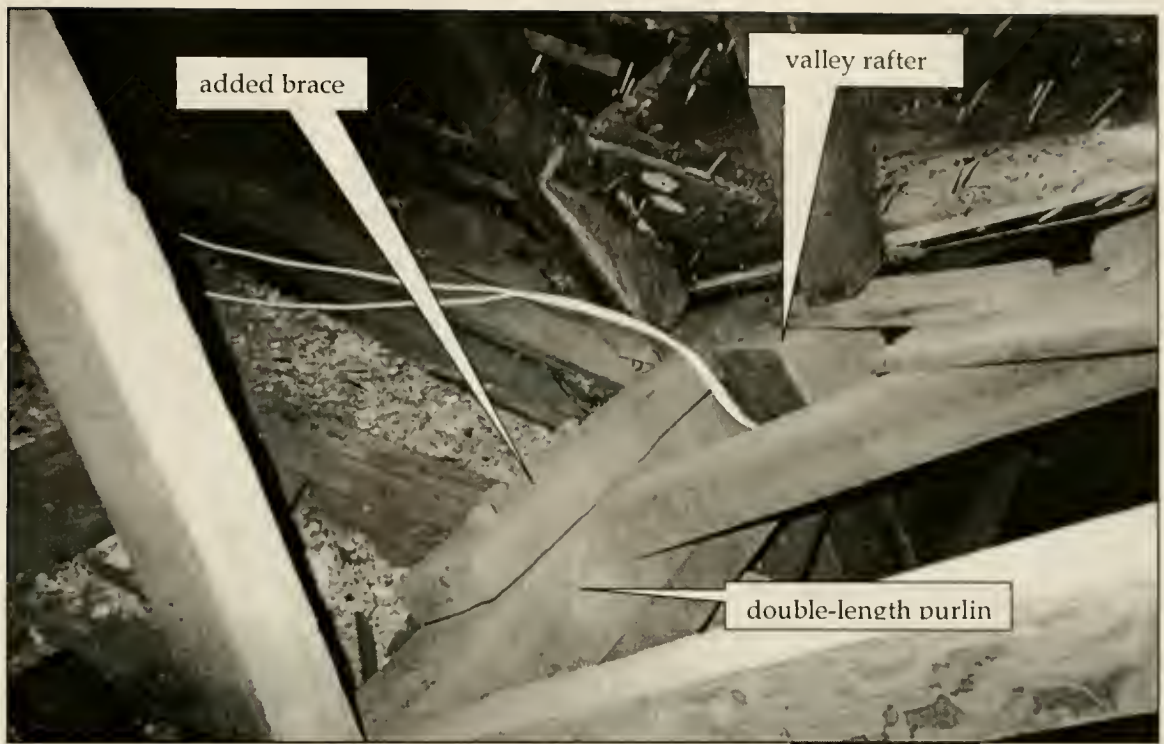
Figure 48:
Southwest roof valley framing, showing
replaced valley rafter and braces added to
reinforce double-length purlin.
Photograph by author, 2002.

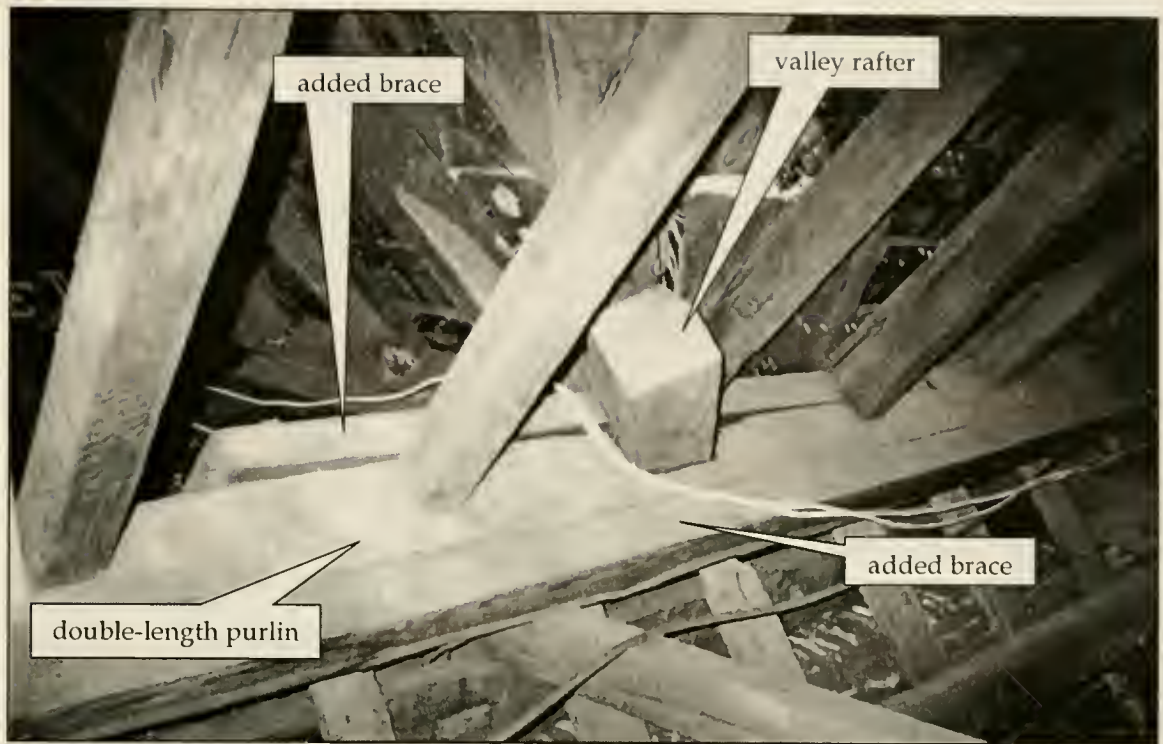
Figure 49:
Southwest roof valley framing, showing
replaced valley rafter and braces added to
reinforce double-length purlin.
Photograph by author, 2002.

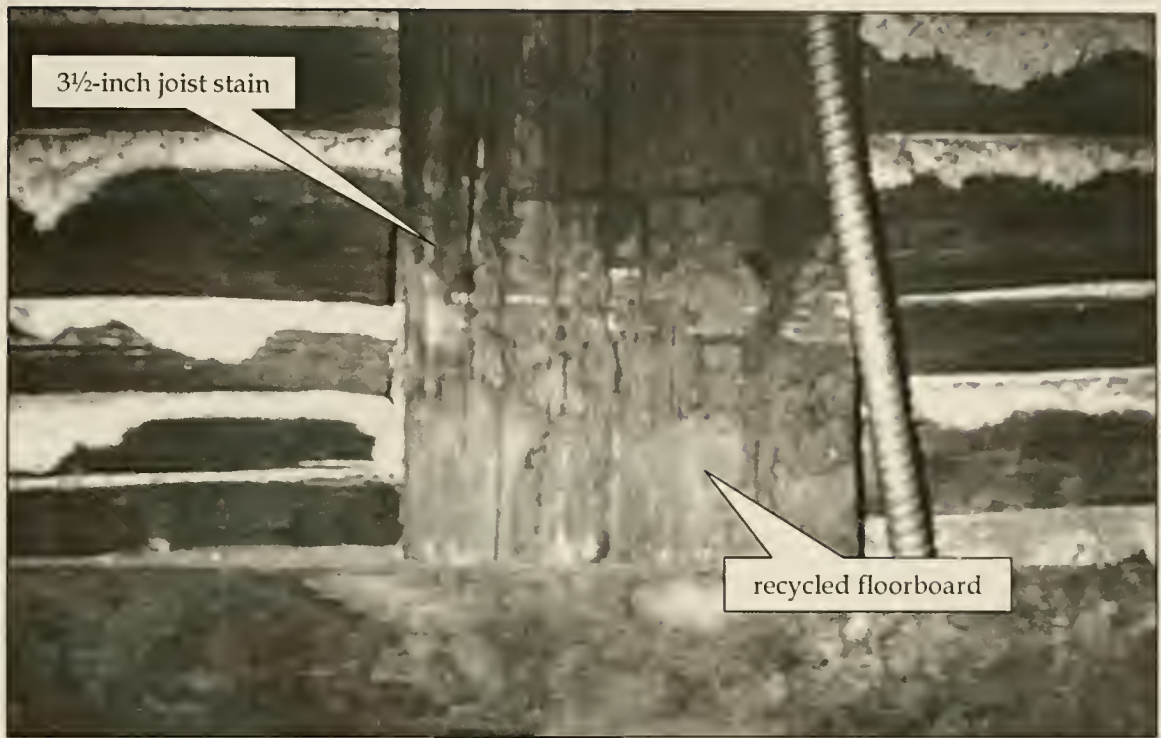
Several boards appear to be recycled flooring. These boards vary in width, ranging from seven to 8- $\frac{1}{2}$ inches wide, but all measure approximately one inch thick. There are stains across the faces of the boards that measure roughly 3- $\frac{1}{2}$ inches wide (Figure 50). These stains occur in a regular pattern on approximately seventeen-inch centers. The dimensions and pattern of the stains suggest that these boards were the original floorboards that corresponded to the joists of the recycled balcony beam (as discussed in Chapter 4). Hand-wrought nails and nail holes can still be found in the center of these joist marks on many of the boards. This evidence suggests that pieces of a former balcony were reused when the current balcony and loft partition were built.

Figure 50:
Detail showing 3½-inch joist stain on
south side of recycled floorboard in loft
partition wall.
Photograph by author, 2002.

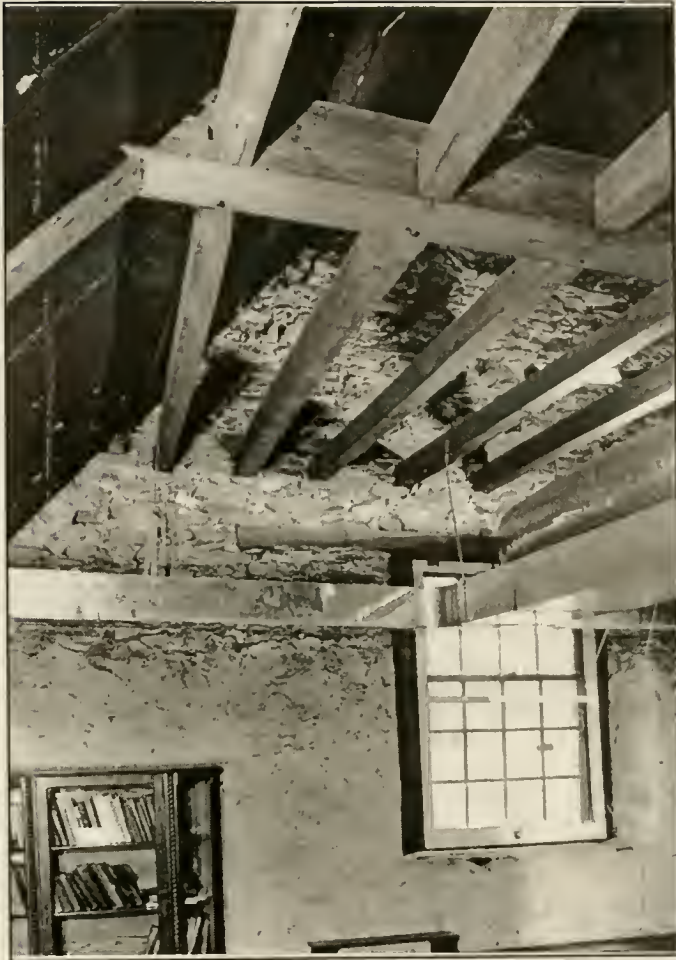
The reason for plastering the masonry above the joists may simply have been to cover the exposed stone and present a roughly finished surface. The gable-end wall is also partially plastered (Figure 51). The height of the plaster is approximately 12 inches below the top of the window opening. The masonry above that is bare. It is also worth noting that the joists that run between the collar beams of the principal rafter assemblies show no signs of being finished to create a ceiling like that over the north section. There are no visible nail holes, lath marks, nor any staining from applied plaster. Unlike the upper portion of the north section, evidence suggests that the roughly finished loft was never meant to serve as an openly public space. If it was intended to be finished in the same manner as the north section, it was never completed.

Figure 51:
Loft over south room looking south
toward gable wall. The unfinished collar
joists and partially plastered south gable
wall are visible.
HABS photograph No. PA-145-35
by Jack E. Boucher, Photographer,
1997-1999.

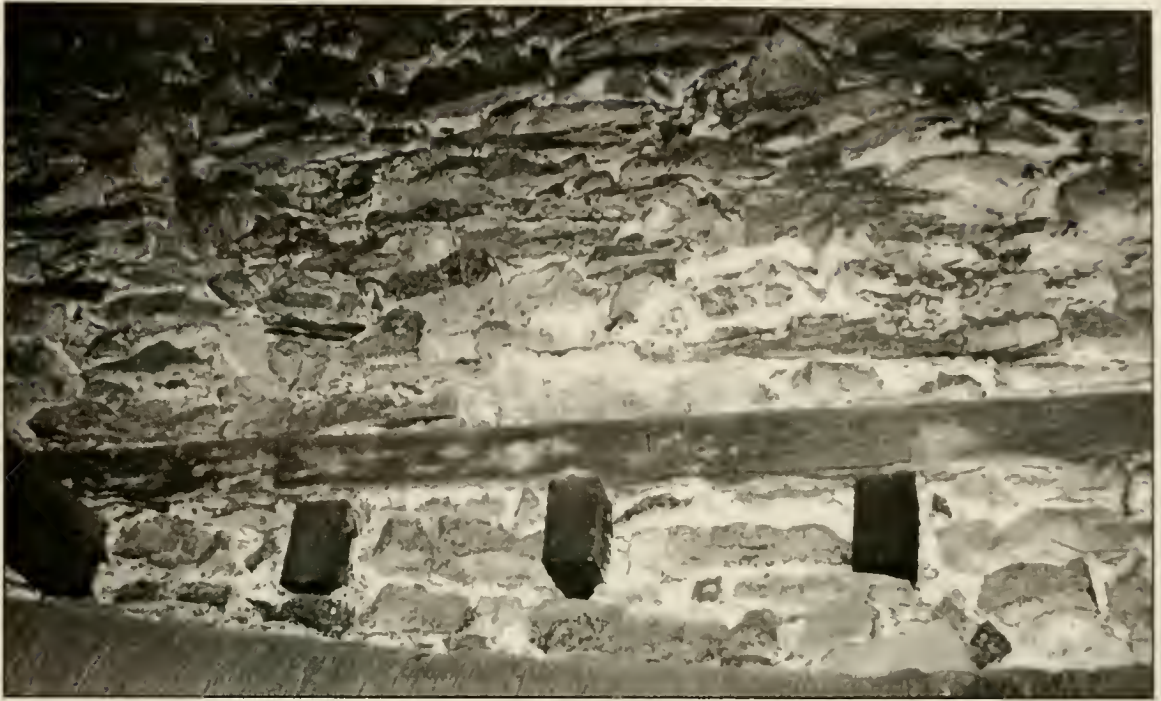
Detail showing cut off collar joists at south gable wall. A leveling plate used by the masons over the joists is also visible.

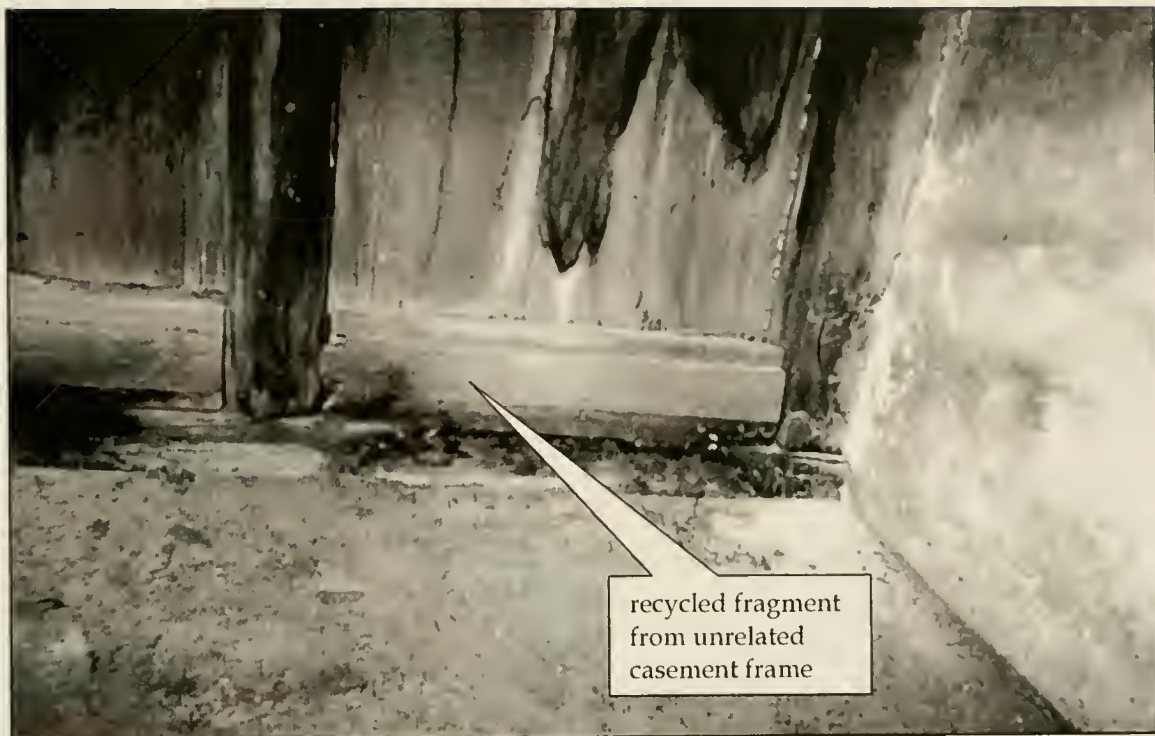
Figure 58:
Recycled fragment of early casement window frame used as nailer for exterior shutters,
northwest gable wall.
Photograph by author, 2002.
